# PRIMARY ADHESIVELY BONDED STRUCTURE TECHNOLOGY (PABST)

## PHASE Ib: PRELIMINARY DESIGN

DOUGLAS AIRCRAFT COMPANY  
MCDONNELL DOUGLAS CORPORATION  
LONG BEACH, CALIFORNIA 90846

TECHNICAL REPORT AFFDL-TR-76-141  
FINAL REPORT FEBRUARY 1975 - OCTOBER 1976

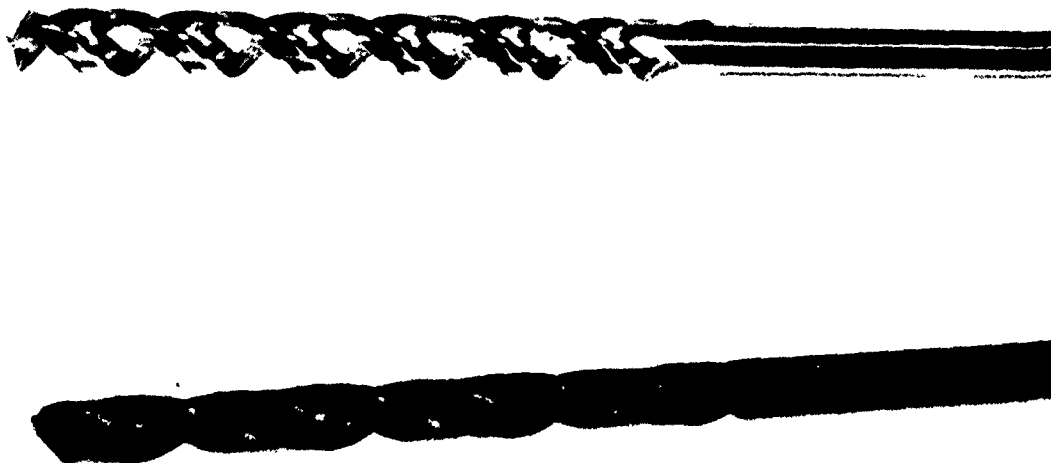
FIGURE 143. DRILL CONFIGURATIONS

All specimens prepared by the three hole generation methods were positioned in a drill fixture or to a drill plate. A new unused drill was used to drill a total of 20 holes in each specimen as shown in Figure 142 with drill configurations as shown in Figure 143. The first, tenth and twentieth holes drilled were visually examined for microinch finish. A ball-gage and a micrometer were used to determine hole diameter, elongation and taper. Exit burr heights were measured with a micrometer. Specimens were subjected to bond line inspection and examination.

The drill fixture was used with slip-fit bushings inserted for centering of drills. A pneumatic power hand motor was used with #20 and 3/16" extension jobbers drills (see Figure 143) to generate the holes. Specimens were drilled dry (without lubricant) and with drills dipped in Type A lubricant.

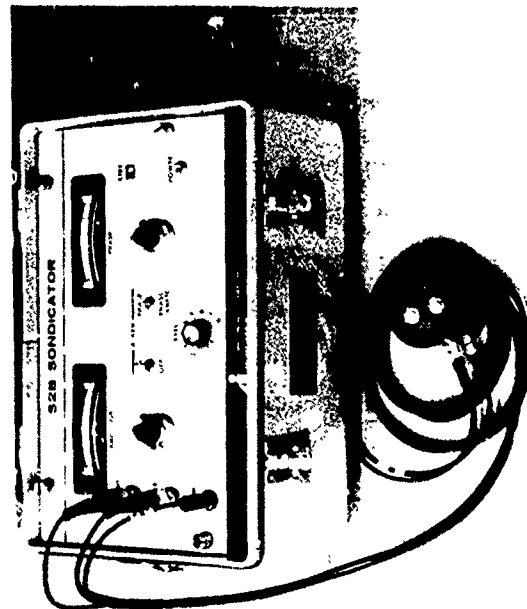
SONDicator

FIGURE 170. BONDTESTING INSTRUMENTS

- Low energy X-ray (5 to 50 Kv)
- Fokker Bondtester
- Sondicator (Automation Industries) Figure 170
- Harmonic Bondtester (Shurtronics) Figure 170
- 210 Sonic Bondtester (NDI instruments) Figure 170
- Ultrasonic Contact Tests (Reflectoscope) Figure 170
  - Pulse-echo ringing
  - Thru-transmission
  - Surface wave
  - Shearwave (Honeycomb only)
- Ultrasonic Immersion Tests (C-scan) Figure 171
  - Thru-transmission
  - Reflector Plate
  - Pulse-echo ringing
- Acoustic Emission (Thermal scanning of defect side or water intrusion side of honeycomb panels)
- Tap Test (coin)
- Neutron Radiography

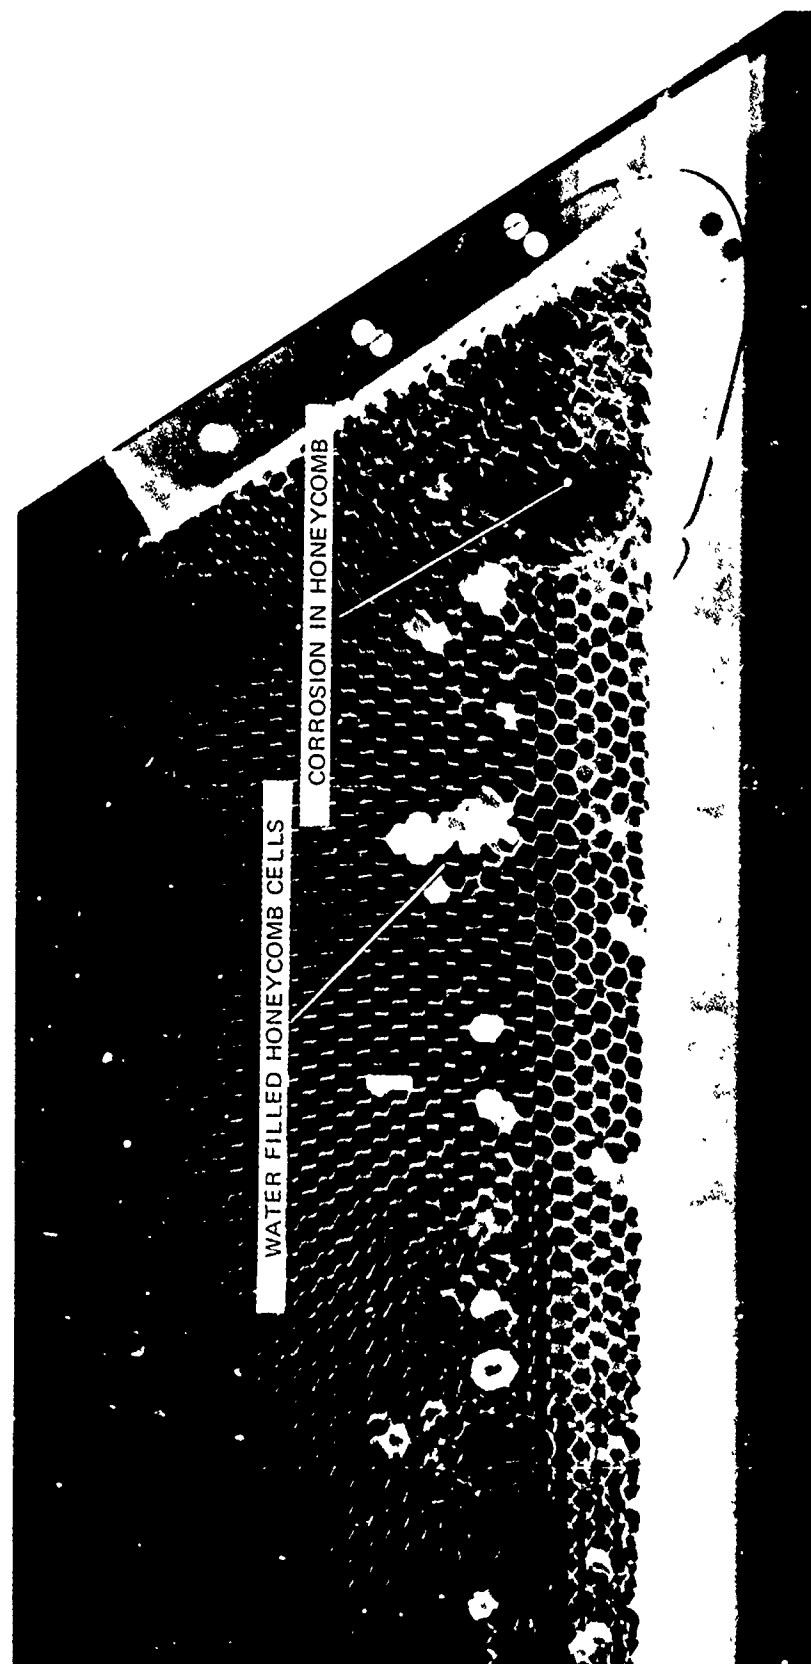
FIGURE 184. RADIOGRAPHIC (X-RAY) OF HONEYCOMB PANELS

Generally, honeycomb assemblies are X-rayed to detect moisture intrusion and corroded core as illustrated in Figure 184. Recently, acoustic emission
